Addendum #1

EOI- Municipal Auditorium Facade Assessment

MUNICIPAL AUDITORIUM ASSESSMENT

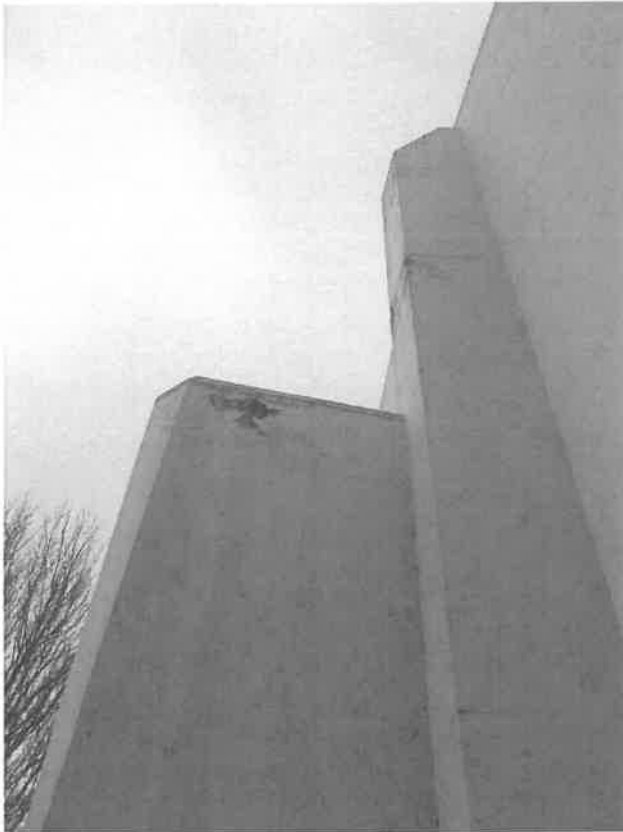
The exterior of the building is exhibiting several issues related to moisture infiltration. From open joints at the coping, to brick mortar joints that appear to be cracked, the worst condition at the exterior is at the west parking lot side of the building. It appears that the lintels over prior window openings have failed, and the brick is rotating out, away from the backup clay tile substrate. This area has been fenced off to keep vehicles and pedestrians away from this side of the building. There are other areas where there is also evidence of brick movement at the exterior, mainly at the upper roof to lower roof wall at the rear. No original drawings of the structure have been found to determine the exact structural framing of the building.

Photo 5: Evidence of Water Infiltration

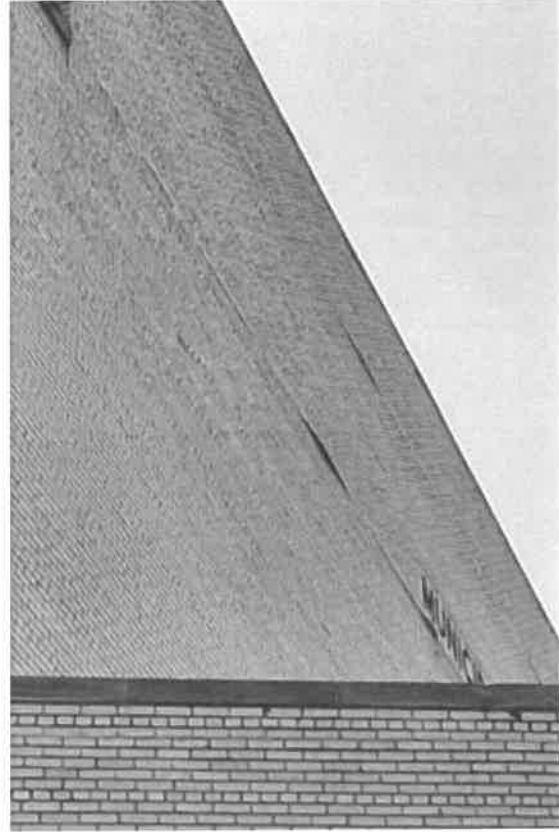
Photo 6: Dislocated Brick

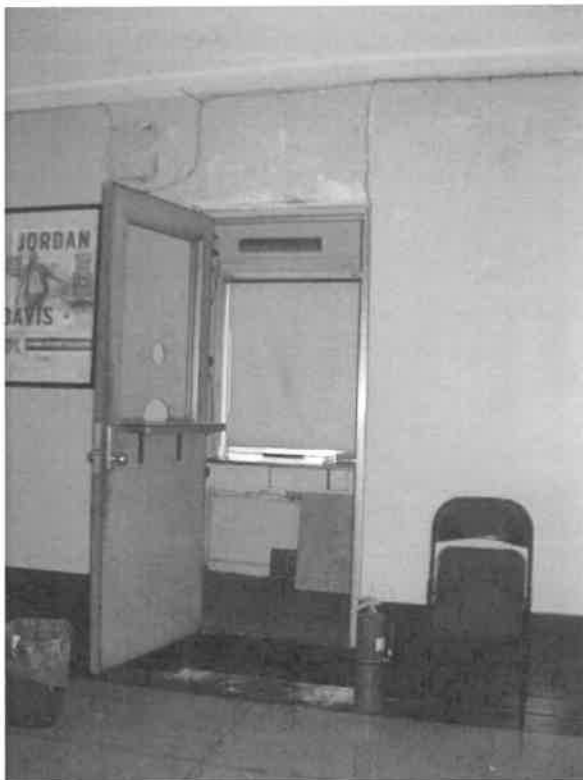
Photo 8: Interior Evidence of Moisture Infiltration

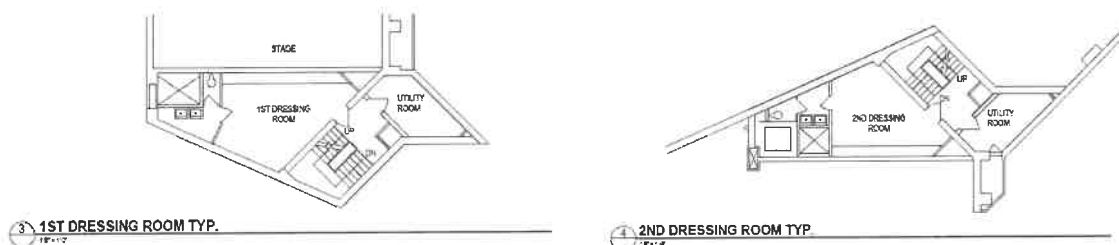
There appears to be adequate egress from the auditorium for 3,500 people. Egress from the stage also appears adequate; however, egress at the front of the stage occurs through the stairs leading to the dressing rooms. Although intended to be egress stairs, they appear to be communicating stairs that connect the dressing rooms (and the gathering space below the stage) to the stage (due to multiple penetrations of the stairwell). Egress from the dressing rooms is inadequate and unsafe. The dressing rooms should not be utilized until improvements to the building are completed.

Figure 3: Inadequate Egress from Dressing Rooms

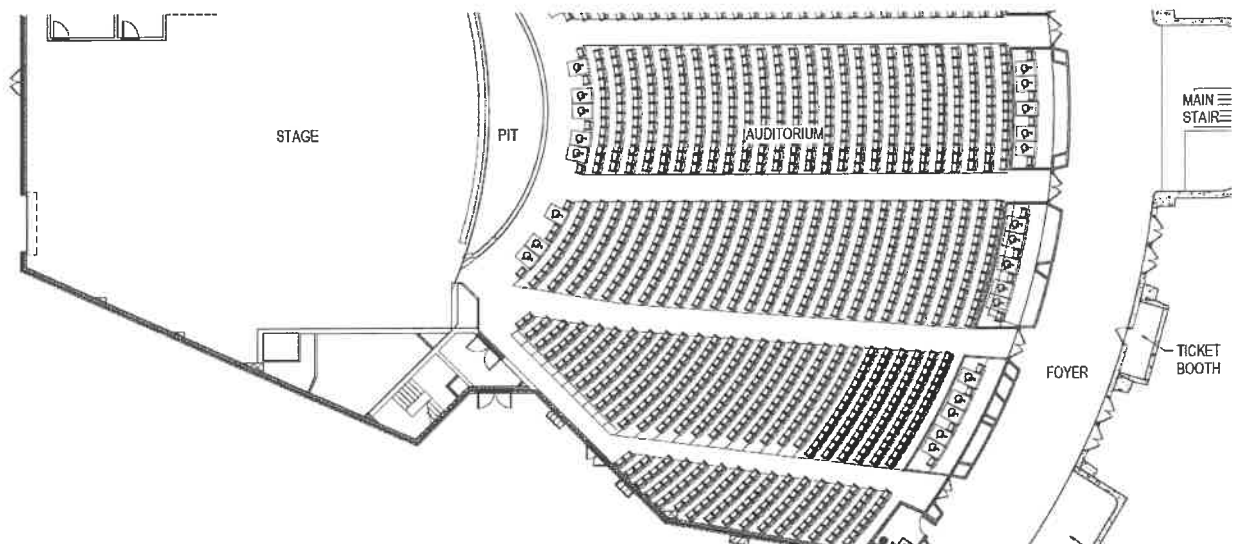
The lobby is accessible, but currently wheelchairs can only be accommodated in the rear of the auditorium (in Section 5). Access to these areas is difficult as the aisle slope begins immediately upon crossing the threshold into the auditorium. The cross scope that leads to the “accessible” area is difficult and unsafe to navigate. The aisles are too steeply raked to allow un-assisted wheelchair access to the front. In the absence of a facility renovation, the width of the front cross aisle would allow seats to be removed for wheelchair placement, with staff assistance becoming an operational consideration without an accessible route.

Figure 4: “Accessible” Seating in rear of Auditorium

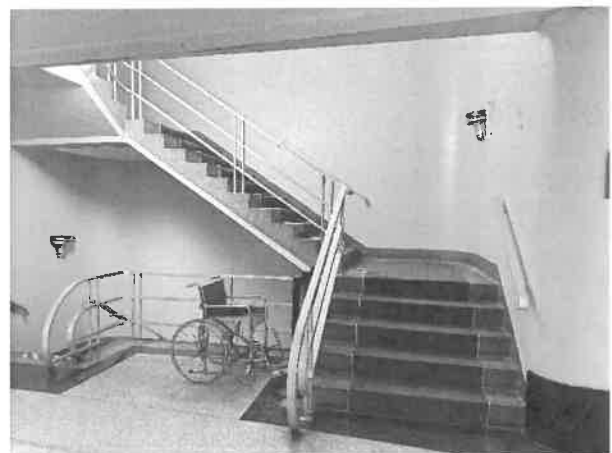
Photo 12: Stair Access Only to Concessions and Balcony

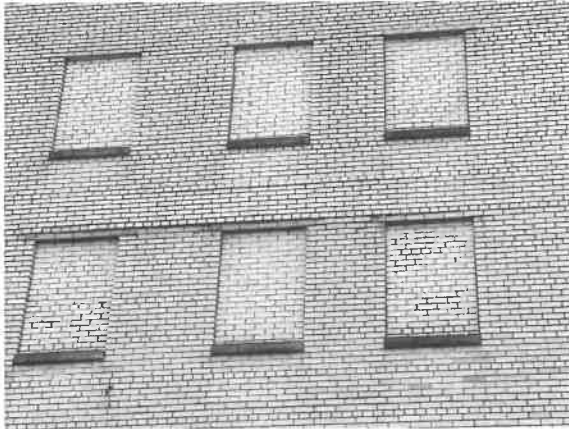
- Displacement of brick: In several places, the brick was observed to be displaced and buckling away from the building:
 - Faux Windows: At the west elevation of the building, significant displacement of the brick was observed between the faux window panels (Photograph 13 and Photograph 14). Per the original drawings, these were steel windows that have since been replaced with a brick infill. Between the top and middle rows of windows, the brick panel was severely buckled, and the brick was protruding from the face of the wall. There is a significant risk for this brick panel to fall based on the observed displacement. Corrosion was also observed at the steel lintels above each faux window (Photograph 15).

Photo 13: Displaced Brick at Faux Windows

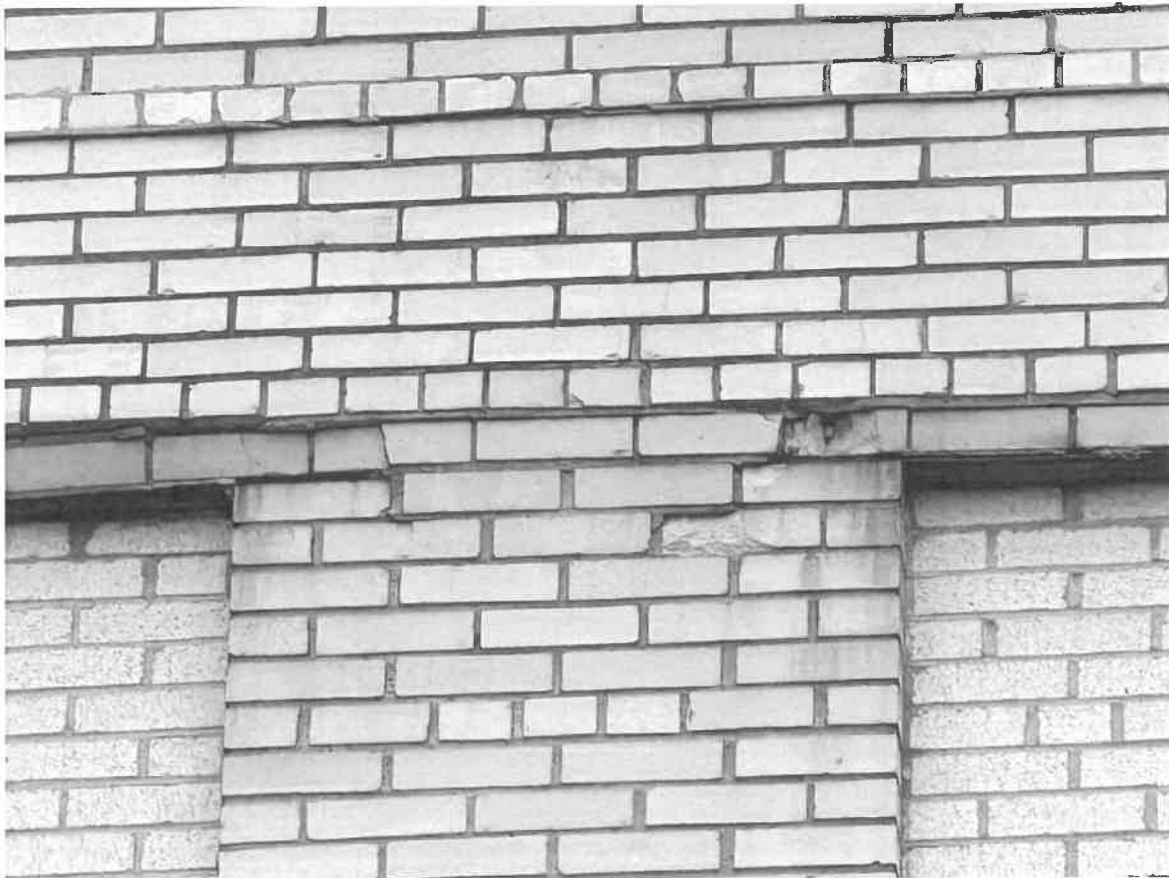
Photo 15: Displacement of Brick Masonry and Corrosion of Steel Lintels

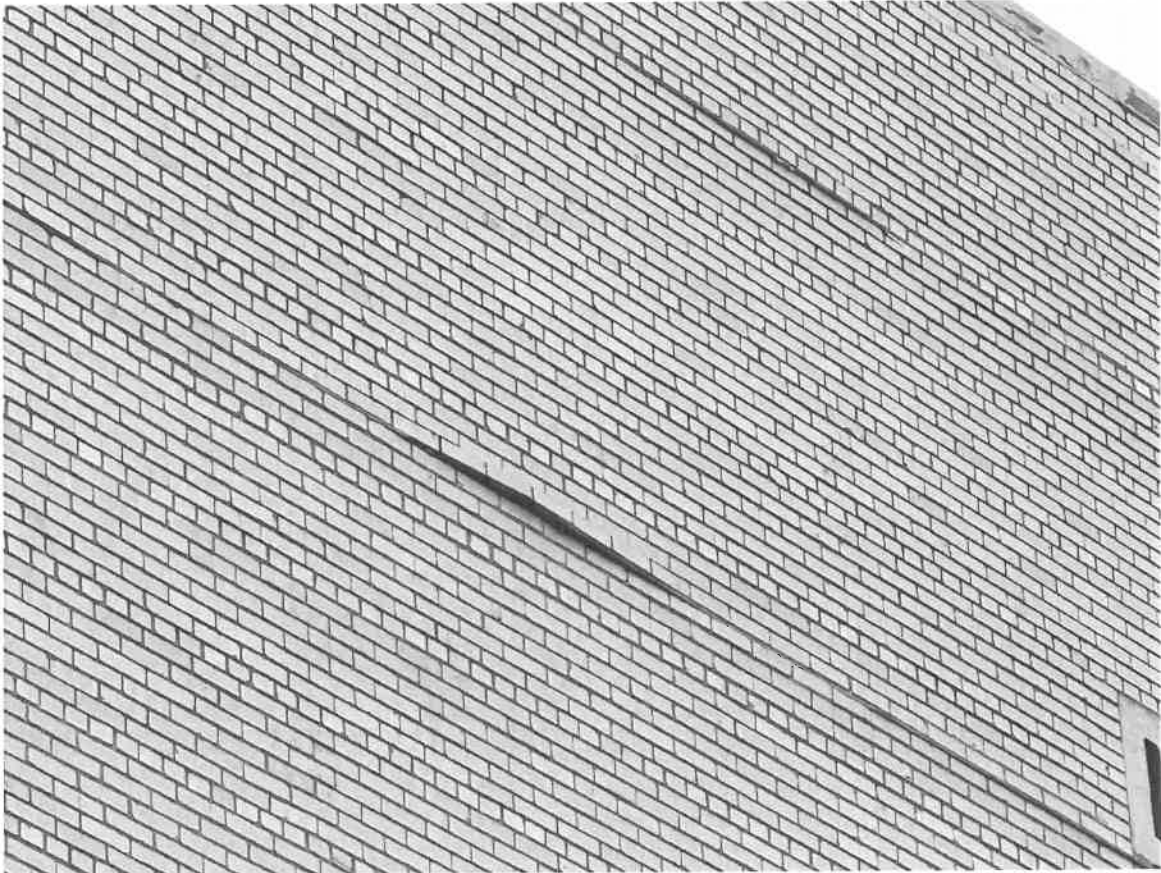
- South Elevation: At the south elevation of the building, significant displacement of the brick was observed above the lower roof. The most significant displacement appears to align with the location of a steel beam within the wall (Photograph 16). This could indicate corrosion of the beam is occurring and expansion of the steel as a result of corrosion is forcing the brick outward.

Photo 16: Displaced Brick at South Elevation

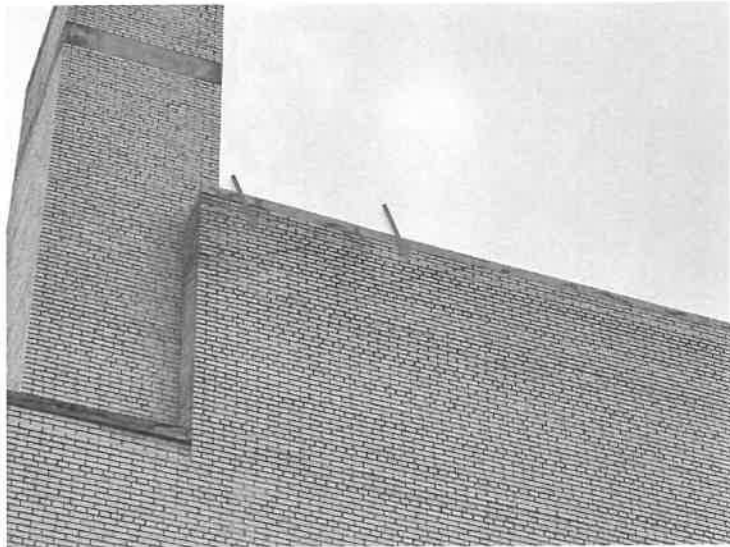
- Cracking of Brick:
 - Walls: Step cracking in the brick masonry was observed throughout the building. Key locations of cracking were observed near the parapet (Photograph 18), near outside corners (Photograph 19), and at the upper penthouse (Photograph 20).

Photo 18: Step Cracking in Brick Masonry at Parapets

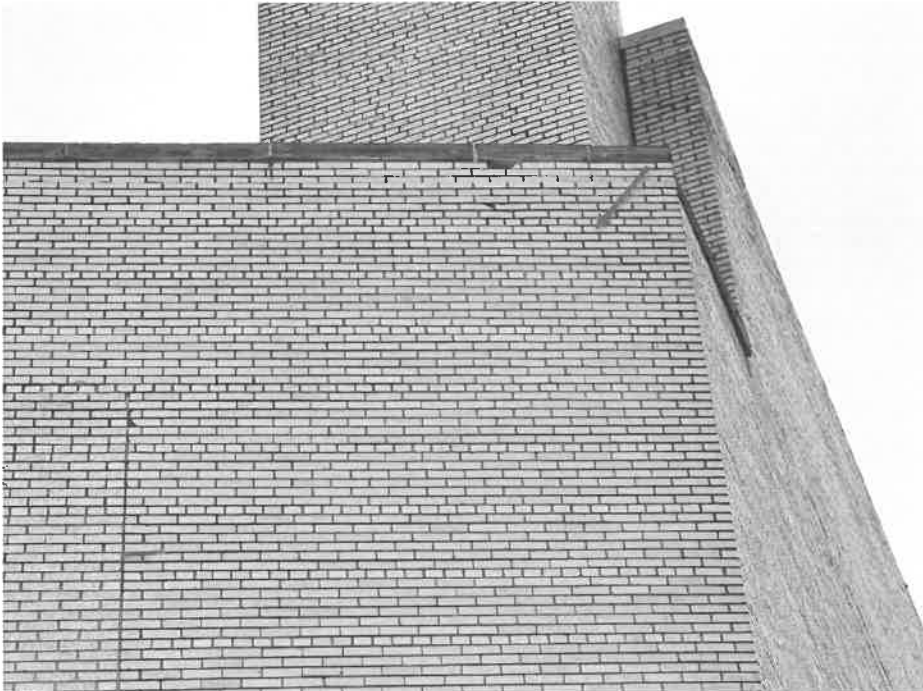
Photo 19: Step Cracking in Brick Masonry at Outside Corners

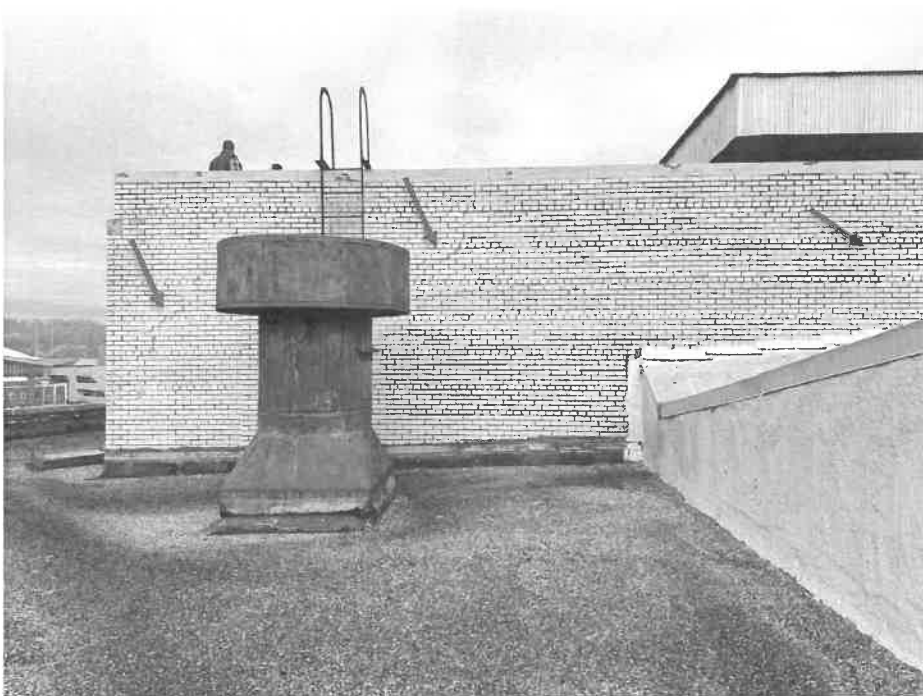
Photo 20: Step Cracking in Brick Masonry at Upper Penthouse

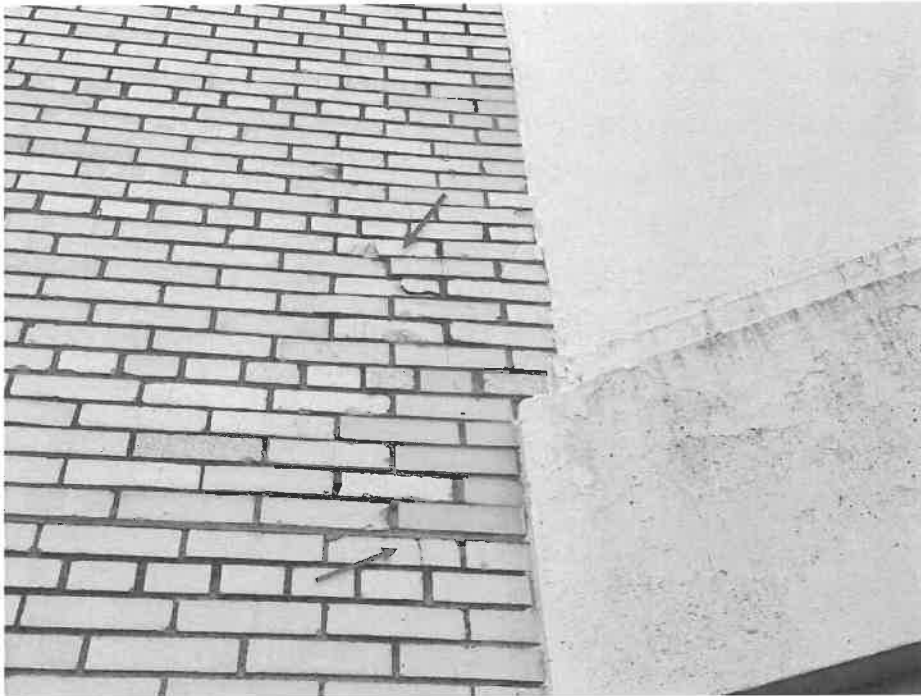
- Integration with Concrete Walls: Cracking in the brick masonry was observed at the integration between the brick masonry and the cast concrete walls (Photograph 21). Provisions for expansion

were not included between these two wall types, so it is likely that this cracking is from stress induced from the expansion of the brick masonry against the concrete wall.

Photo 21: Cracking of Brick Masonry at Concrete Wall

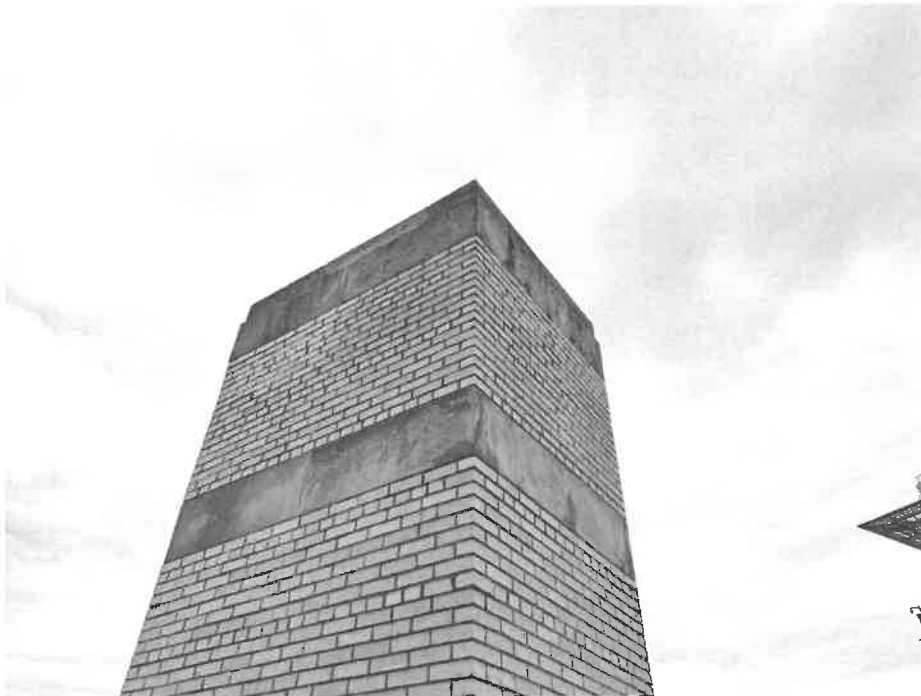
- Deterioration of stone elements: Stone elements are integrated into the brick walls at the chimneys and at the top of pier caps at the exterior walls. The parapets are also capped with stone. The stone units were observed to be deteriorated and spalled in many locations (Photograph 22).

Photo 22: Deterioration of Stone Within Wall Elements

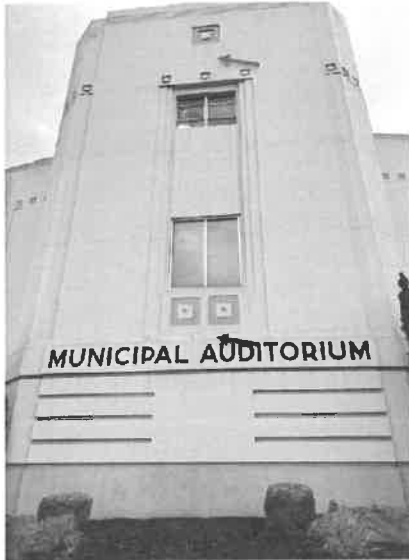
- Vertical cracking: A vertical crack was observed in the façade of the cast concrete wall (Photograph 23 through Photograph 25). This crack appeared to propagate through the entire height of the wall. Further evaluation would be required to determine the cause of this cracking.
- Paint failures: The painted surface of the concrete façade was observed to have failures in some locations (Photograph 26). It appears that water has penetrated behind the painted finish and caused it to fail.

Photo 23: Vertical Cracking in Cast Concrete Façade

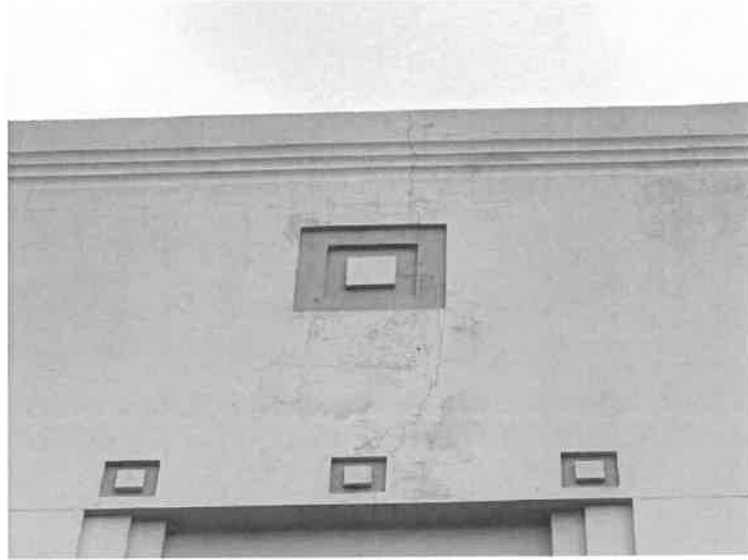
Photo 24: Vertical Cracking at Top of Wall

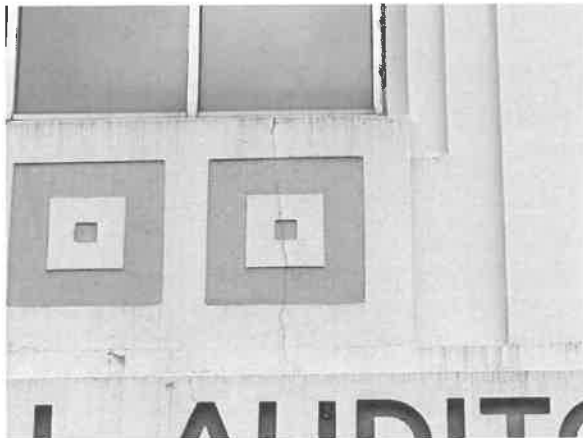
Photo 25: Vertical Cracking at Bottom of Wall

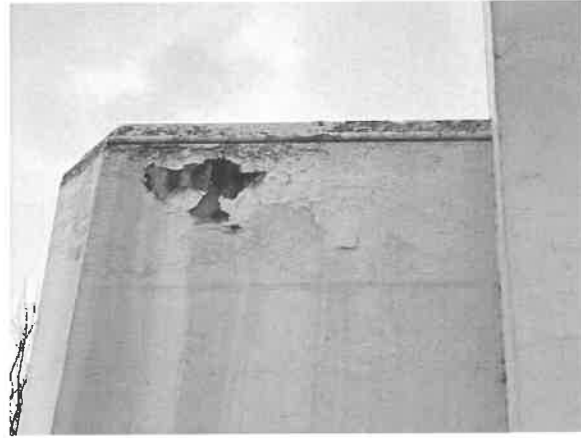
Photo 26: Paint Failures at Cast Concrete Façade

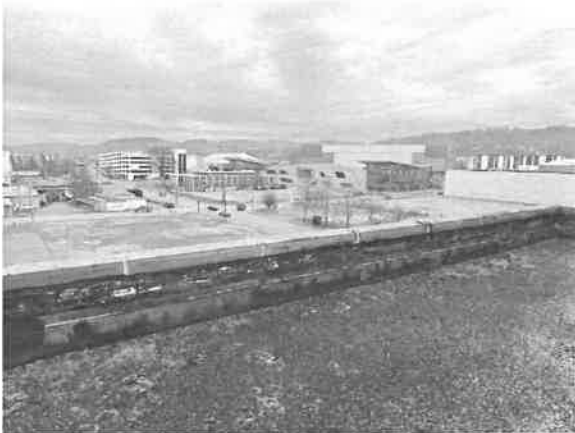
Photo 27: Typical Staining and Biological Growth at Roof Assembly

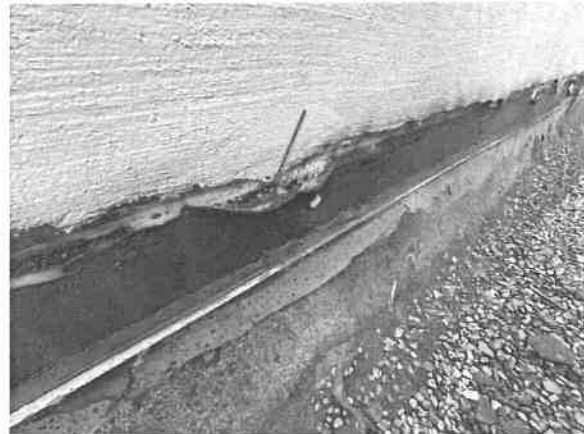
- **Drainage provisions:** With the size of the flat roof assembly, there were limited drainage provisions for the roof. Roof drains were only observed in a few locations, and the staining patterns and biological growth (Photograph 27) throughout the roof indicate that the roof is not draining sufficiently.
- **Termination:** Where the roof terminates against adjacent brick masonry and parapets, potential paths for water to penetrate behind the roof membrane were observed (Photograph 28 and Photograph 29).

Photo 28: Pocket in Roof Termination

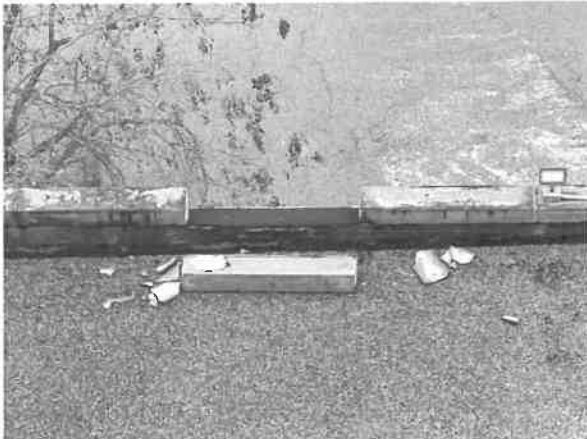
- Displaced stone units: One of the stone units at the parapet was observed to be displaced onto the roof (Photograph 30). It is unclear how this stone became displaced; it appears to have been knocked loose by force, rather than through natural weather events.

Photo 30: Displaced Coping Stone Unit

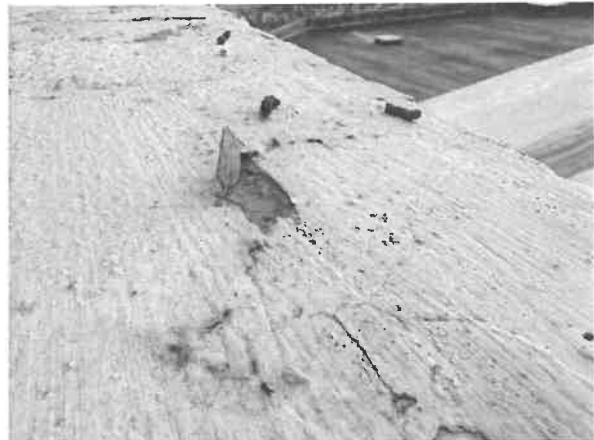
Photo 31: Typical Coating Failure at Parapet Coping Stone

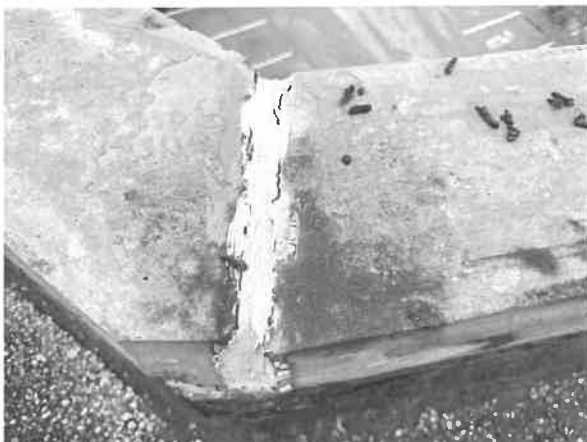
Photo 32: Sealant Joint Failures

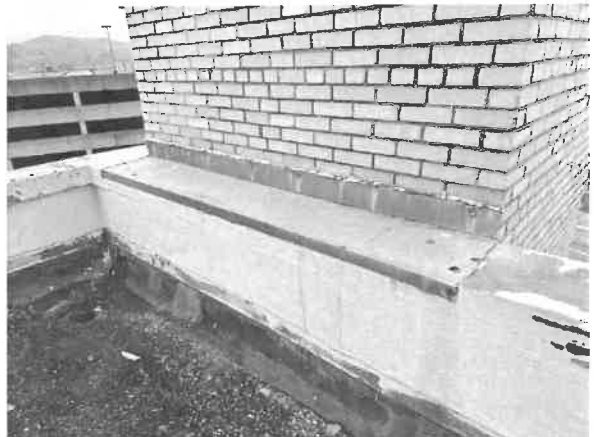
- Flashing integrations at chimney: Sheet metal flashing was observed at the base of the chimney that turned out and over the parapet. The extents of the flashing were not terminated or sealed, creating a direct path for water to penetrate under the flashing (Photograph 33).

Photo 33: Flashing at Chimney Integration

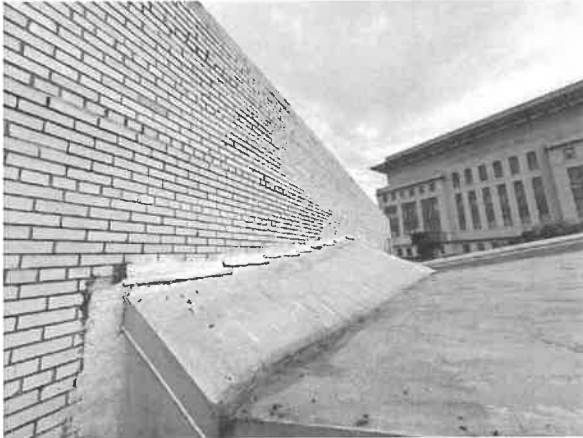
- Integration with masonry wall: The sheet metal roofing assembly at the center of the main roof was integrated with the face of the brick masonry wall (Photograph 34). Without a drainage plane in the masonry wall to integrate with, there is the potential for water to penetrate behind this roof termination.
- Coating failures: A coating had been installed over the metal roof assembly. There were locations where the coating was observed to be failing (Photograph 35).

Photo 34: Sheet Metal Integration with Masonry Masonry Wall

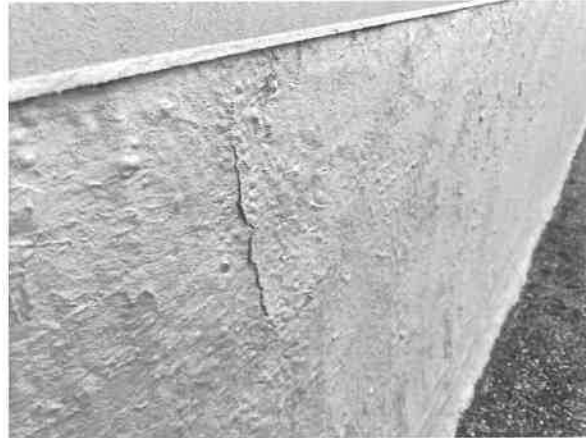
Photo: 35 Coating Failures at Sheet Metal Roof

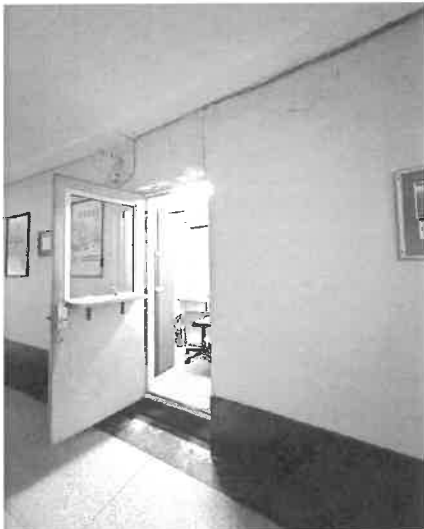
- Water infiltration at ticket office: Significant plaster damage was observed over the ticket office at the south elevation of the building from apparent water infiltration (Photograph 36). It is likely that the source of water infiltration is at the integration of the awning and the concrete wall (Photograph 37). Further evaluation would be required to determine the source of water infiltration.

Photo 36: Interior Plaster Damage at Ticket Office

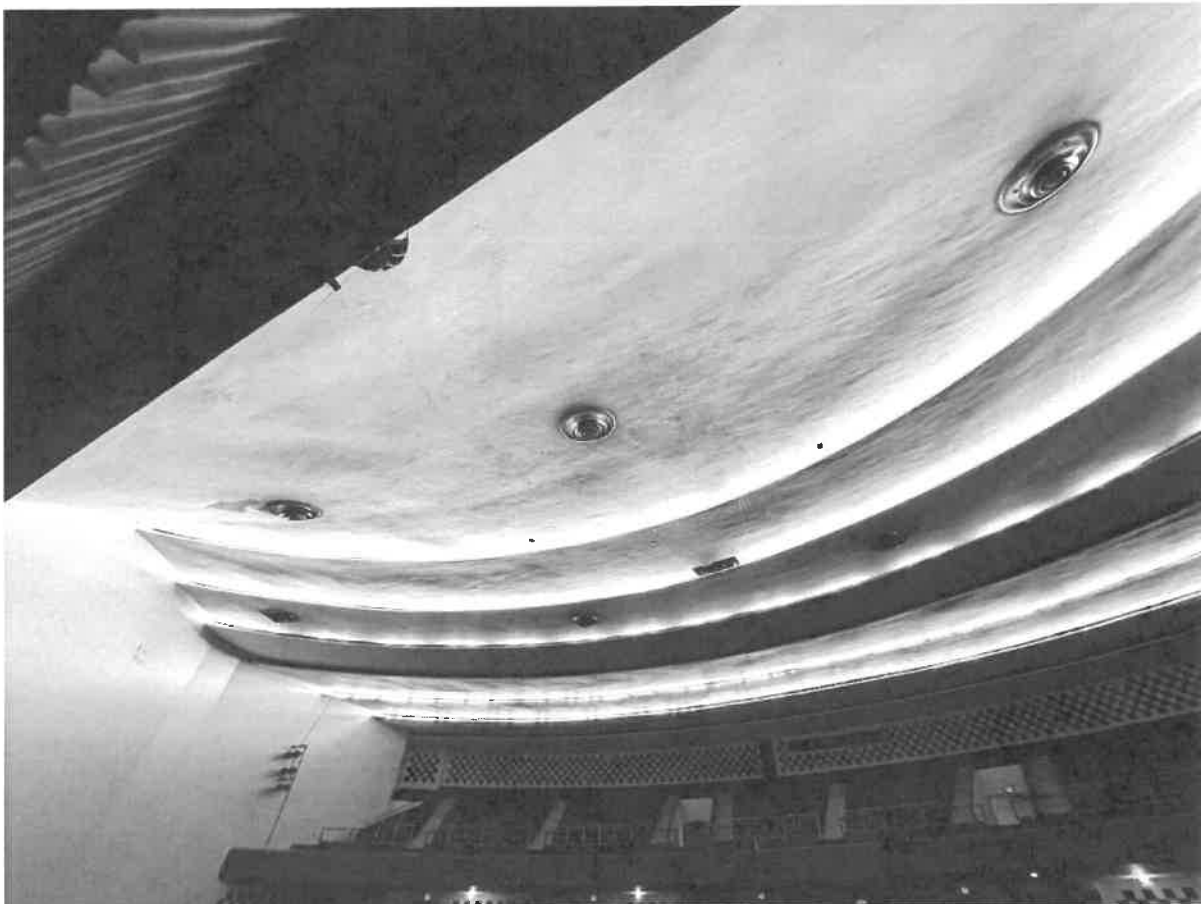
The plaster ceiling within the theater is suspended from above. There is a significant amount of moisture-related damage observed in the plaster ceiling, either from bulk water infiltration or moisture-related issues from the mechanical system (Photograph 38). The original drawings indicate it is installed over metal lath and anchored to channels that are secured to steel framing above with hangers. Due to the amount of water infiltration that has occurred through the roof, a visual inspection of this plaster should be performed from above to verify whether corrosion is present and if the structural integrity of the plaster ceiling has been compromised.

Photo 38: Plaster Damage at Interior Ceiling of Theater

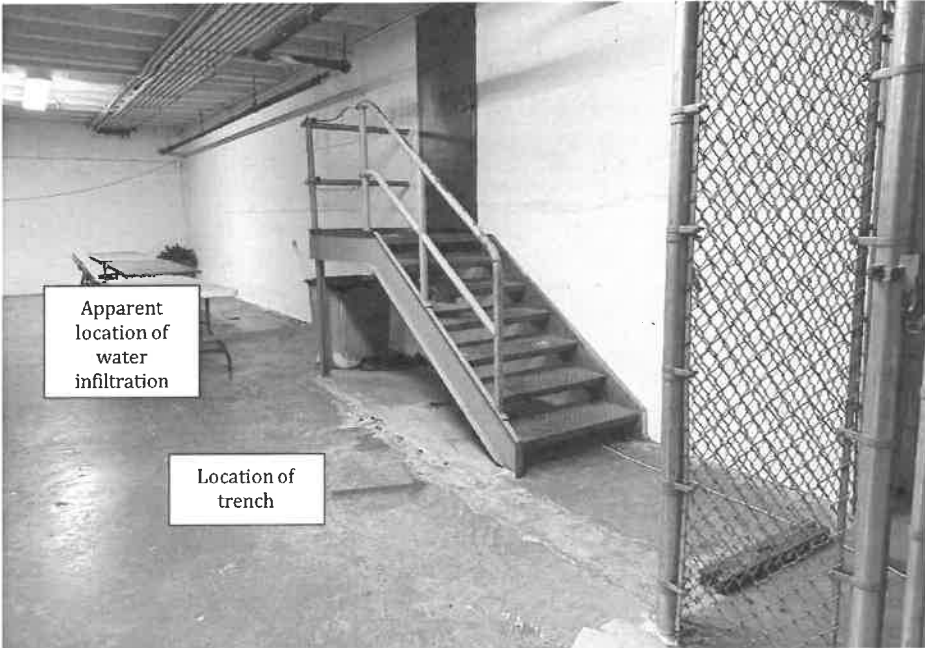
Water infiltration was noted in the basement during the interior tour, although it was not actively leaking at the time of the WDP site visit. Where significant water infiltration is known to occur, a series of trenches have been cut within the concrete floor (Photograph 39) to drain water to a pit where a sump pump is used to manage the water (Photograph 40). The source of the water infiltration is unknown, and it was noted to occur at interior walls. Further evaluation would be required to determine if the water infiltration is a result of the elevation of the water table, below-grade water infiltration at the perimeter that is making its way to interior portions of the building, or another source.

Photo 39: Water Infiltration at Basement Level

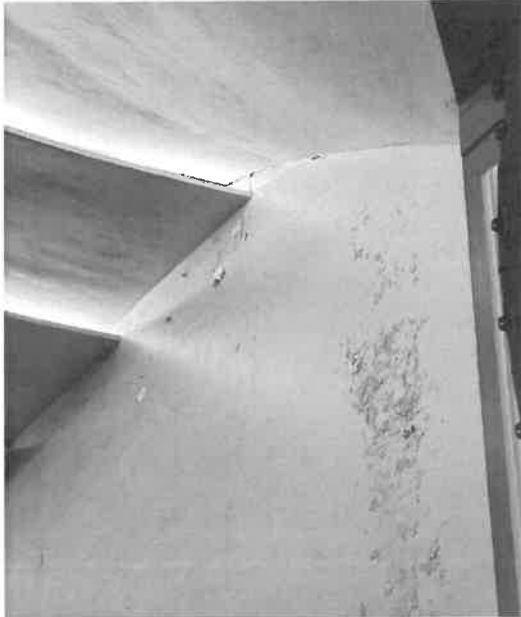
Throughout the theater space, plaster damage was observed as a result of either water infiltration or interior moisture-related issues (Photograph 41). As part of a restoration effort, repairs would be required to restore the interior plaster.

Photo 41: Typical Interior Plaster Damage in Auditorium

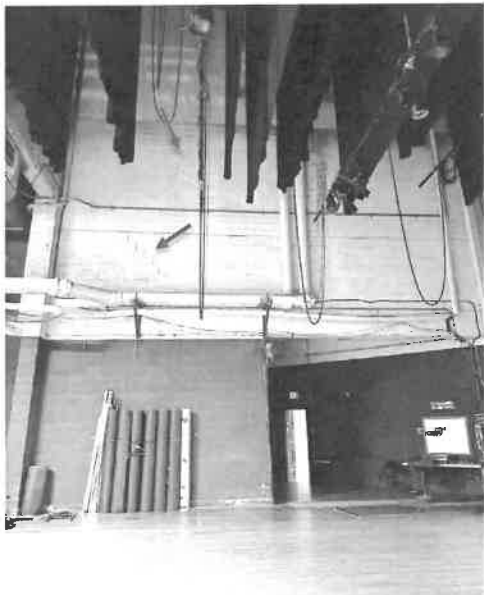
At the interior demising CMU walls adjacent to the stage, cracking was observed (Photograph 42). Further evaluation of these walls and the need for reinforcement or anchorage would be required.

Photo 42: Cracking in CMU at Interior Wall

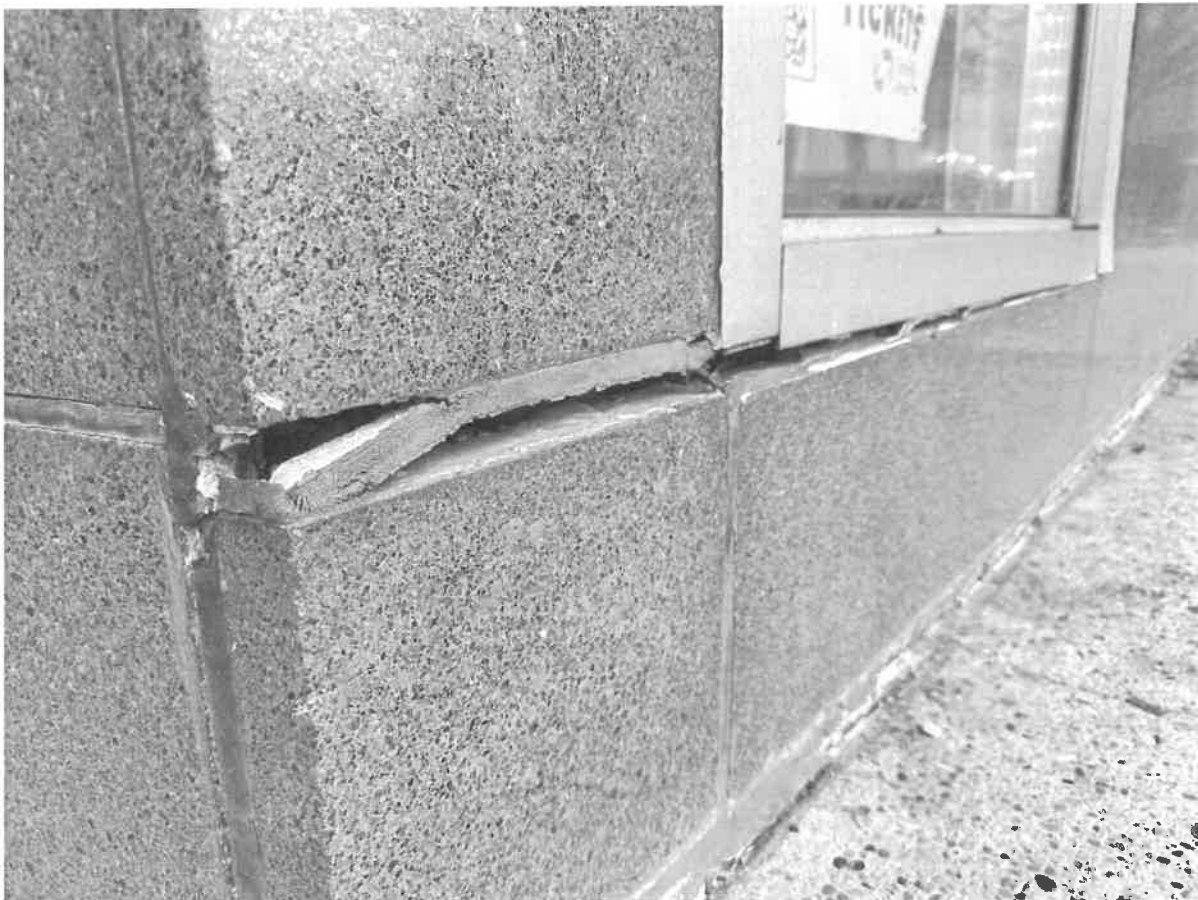
- Ticket office settlement: At the ticket office, evidence of settlement was apparent in the separation of the granite panels, as well as around the storefront windows (Photograph 43). Beyond this being a structural concern, this also provides paths for air and water infiltration into the building.
- Sidewalks: Settlement has occurred at the sidewalks around the entrances (Photograph 44). Where differential movement occurred between sections of the sidewalk creating a hazard, the concrete has been cut to provide a smooth transition between sections.
- Cracking of steps: Cracks were observed in the concrete steps adjacent to the building (Photograph 45). This appears to be a result of settlement under the steps causing differential movement and separation between portions of the stairs.

Photo 43: Separation in Joint in Granite Panels and Around Storefront Window

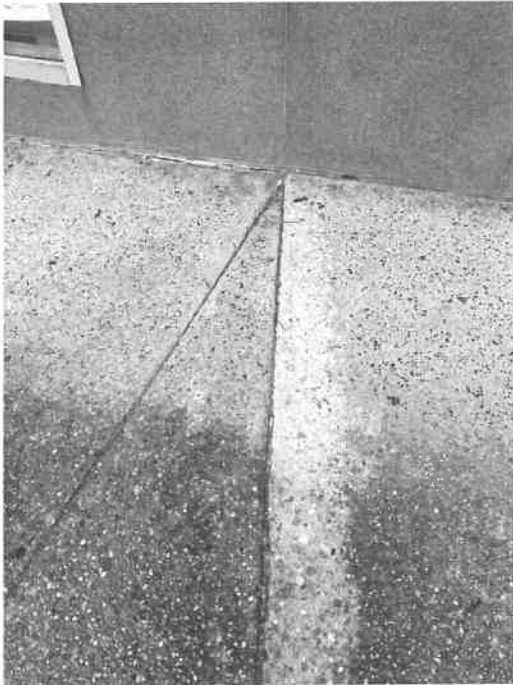
Photo 44: Concrete Cut Back to Limit Trip Hazard Due to Settlement

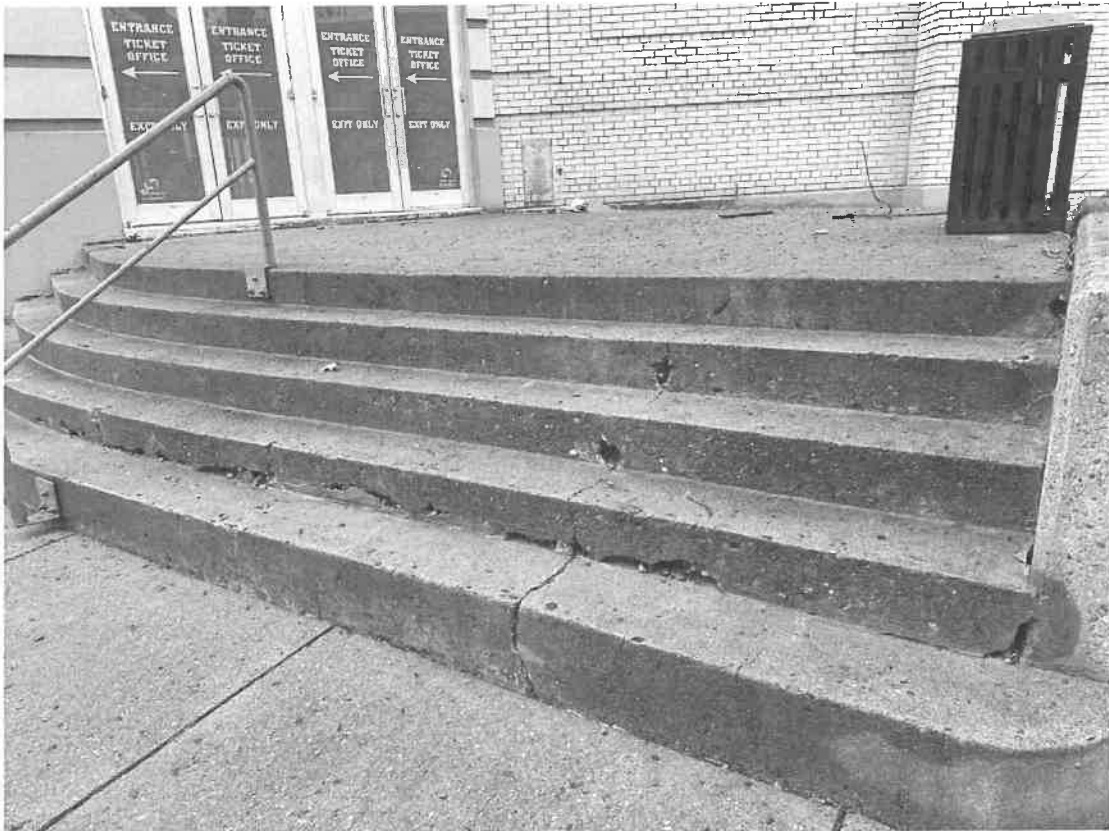
Photo 45: Cracking in Concrete Stairs

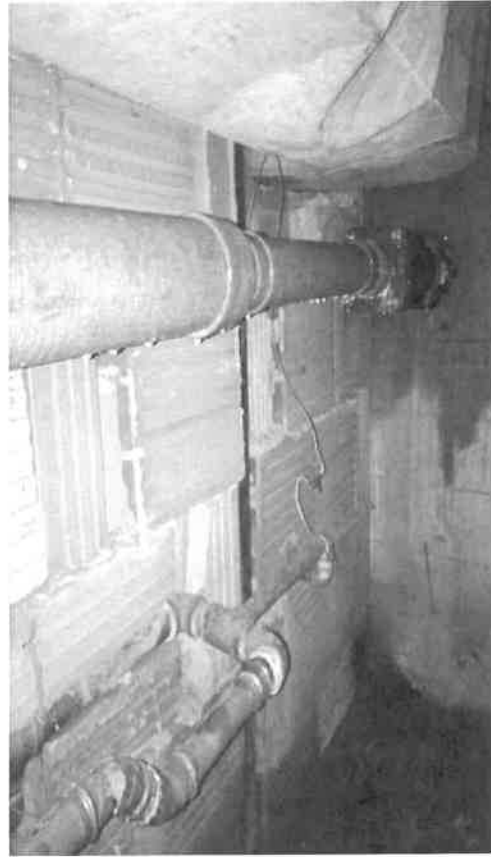
The facility is served by a galvanized 4" domestic water line that enters the corner of a utility closet in the basement. The potable water has a Watts model 957 backflow preventer installed on the main line in the utility closet. The backflow preventer was last tested in 2019 according to the inspection tag. The domestic service directly downstream of the backflow preventer is a copper line, but throughout the facility, the water piping material is a mixture of copper and galvanized. All galvanized domestic water should be replaced with Type L copper throughout the facility.

Photo 47: Copper and Galvanized Piping

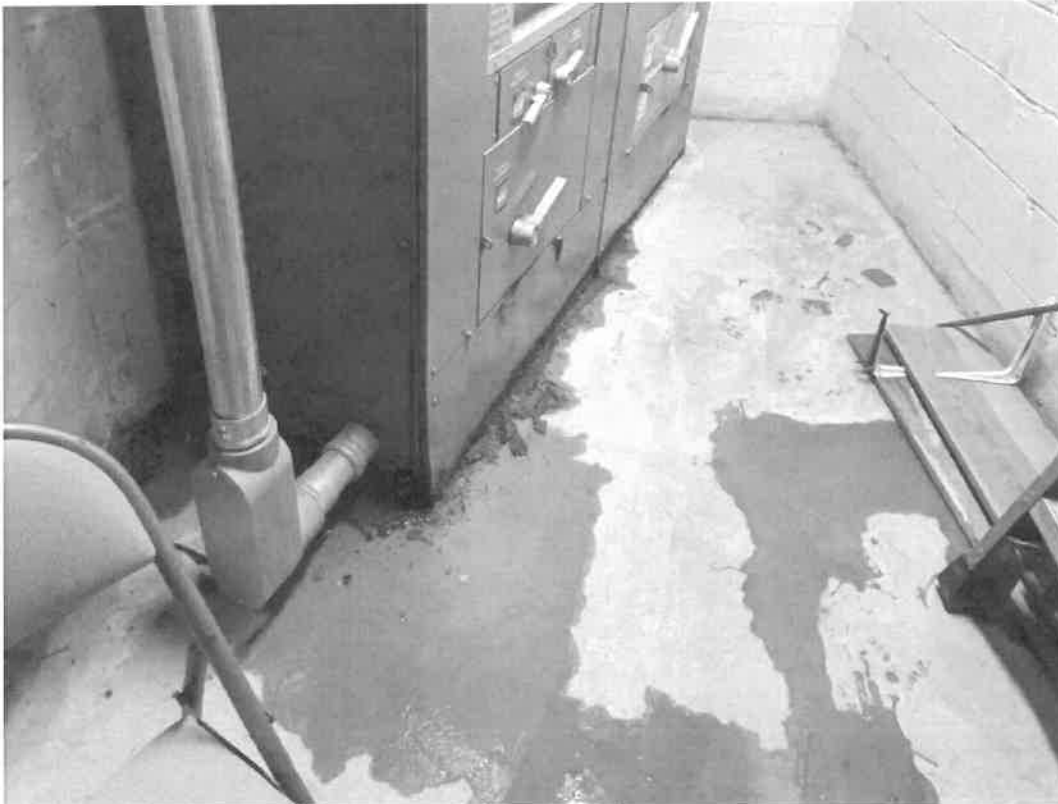
On January 30, 2024, the initial electrical assessment was completed. During this assessment the main service switchgear (located in the basement) serving the entire auditorium building was observed to be in standing water. Water leaking out of the base of the gear and significant rust at the base of the gear was identified as an immediate concern that required correction if the building was to remain occupied. The observed condition could be deadly if there is an arc flash (explosion), in which case anyone near the service would be killed. Additionally, due to proximity it would likely immediately destroy the main fire alarm control panel. Power would be disabled to the building, and it could cause a fire.

Photo 52: Water Seeping Out from Switchboard

Based upon the observed condition ZMM recommended that the building be closed until the gear is replaced or repaired and all components certified to comply with protection requirements by the manufacturer or third-party testing agency. AEP was contacted to disconnect the service, which permitted Mark Nary from M&L Electric to access the site and open the de-energized switchboard. M&L Electric observed that the water was likely entering around the conduits where they entered the building. The gear was observed to be extremely brittle in certain areas and rusted through in several spots. Oxidation was also observed on the lugs as well as the cables and bus. The main causes of arc flashes in industrial/commercial switchgear are the use of tools to energize switchgear, the deterioration of the insulation on phase bus bars, and loose connection that overheat. The actual flash is the light and heat from the explosion. A significant amount of corrosion was observed on the de-energized bus and

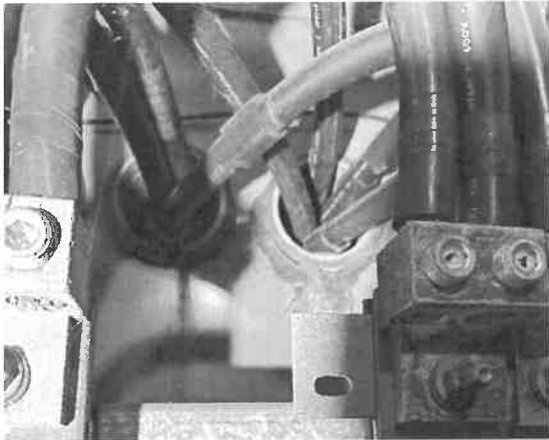
Photo 53: Interior of Switchboard - Rust Around Conduits Service Indicating Likely Point of Water Infiltration

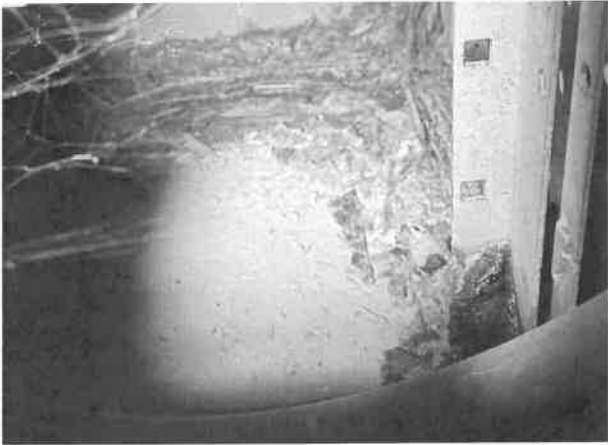
Photo 54: Interior of Switchboard - Rust Around Base of the Gear

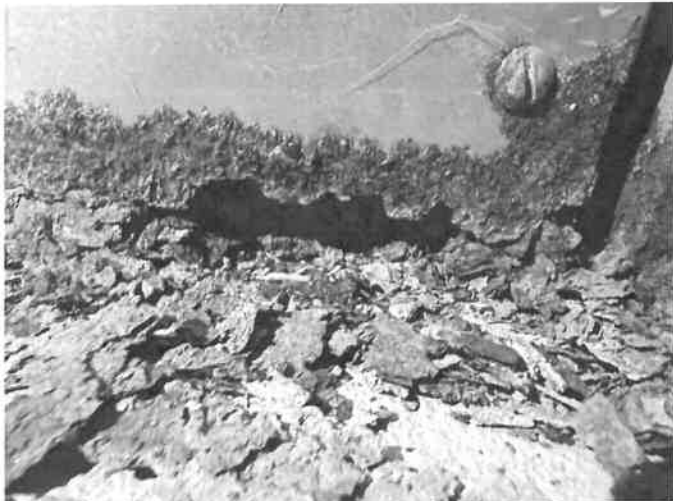
Photo 55: Exterior of Switchboard - Rust Around Base of The Gear

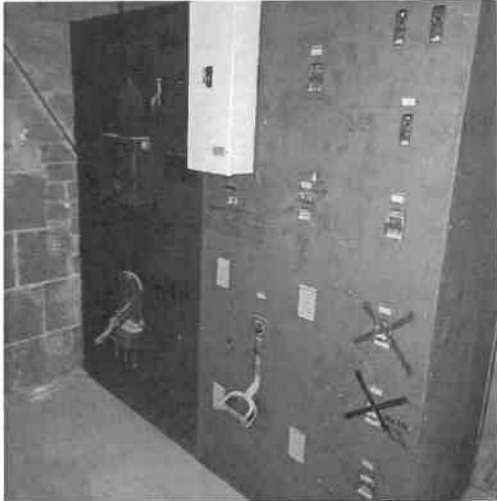
There is also a mix of disconnected and abandoned equipment throughout the building, primarily around the stage and in the penthouse electrical room. It appears that the majority of the equipment has been disconnected, however there are ‘newer’ (80s or earlier) disconnect switches potentially tapping the lines and conduits still connected to the equipment. One older model disconnect switch has text written on it indicating that the wires within are still hot and to not turn on the switch. In the event of any renovation, all abandoned equipment throughout the building should be entirely disconnected, removed, and all feeders capped off in a safe manner or pulled back to their source.

Photo 56: Dilapidated (Abandoned?) Gear in Penthouse
