Addendum #1

EOI- Municipal Auditorium Facade Assessment

MUNICIPAL AUDITORIUM ASSESSMENT

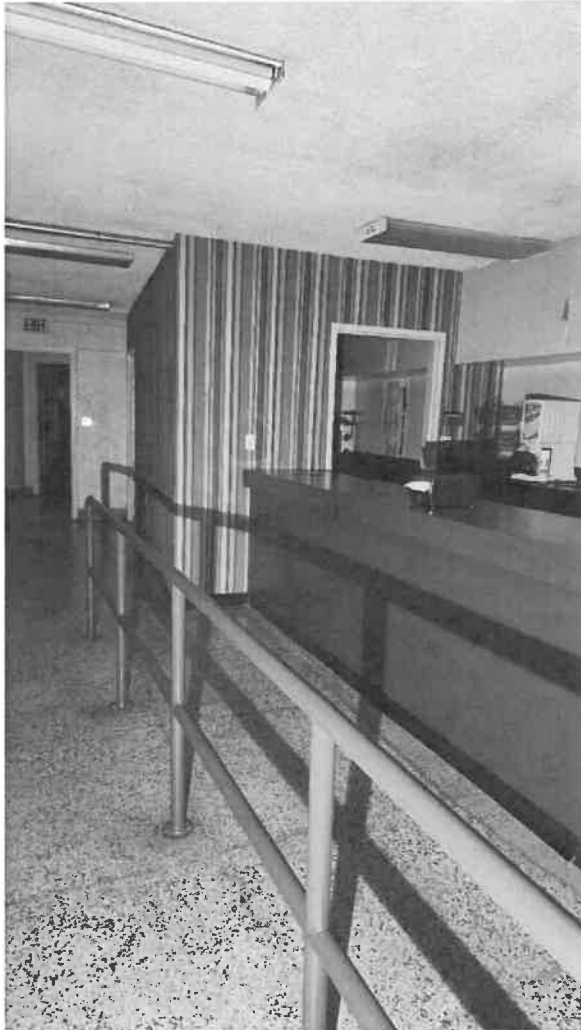
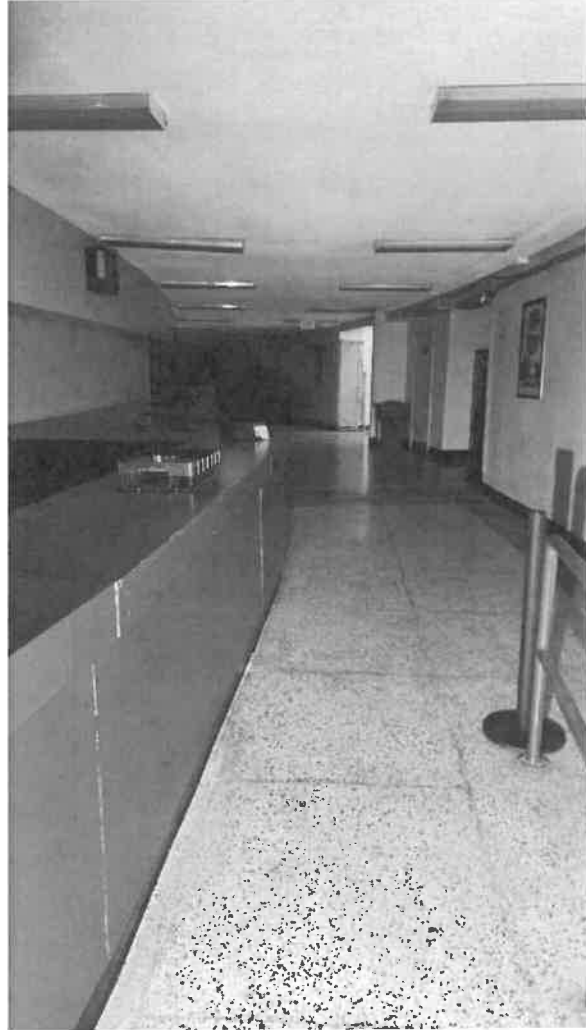
The kitchen and concession areas were created in the basement during a renovation in the 1990s. The spaces are dated and wholly inadequate for a modern concert venue. At a minimum the concession areas need to be moved to the main level with adequate space for queuing. Ideally, the concessions and bar areas would be distributed throughout the venue to provide ease of access for the audience.

Photo 71: Basement Concession Area

Photo 72: Basement Concession Area
