Addendum #1

EOI- Municipal Auditorium Facade Assessment

MUNICIPAL AUDITORIUM ASSESSMENT

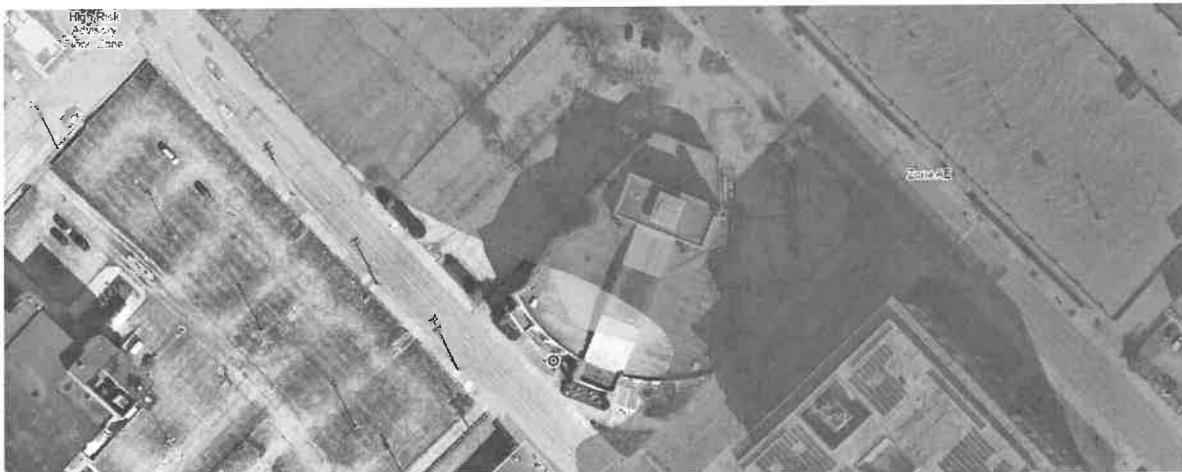
The site for the Municipal Auditorium sits with the 100-year flood plain. The only portion of the building not located in the flood plain is the main entrance on Virginia Street. The base floor elevation is 594’, and the elevation at the entry is approximately 596’. The stage elevation is 4.5’ lower than the entrance, meaning that it is 2.5’ below the 100-year flood plain. If there is a substantial renovation the entire building will need to be flood proofed to 596’ (100-year flood plain plus 2’). This will require significant analysis and expense. A map indicating this area is provided, below:

Figure 1: Image from West Virginia Flood Tool

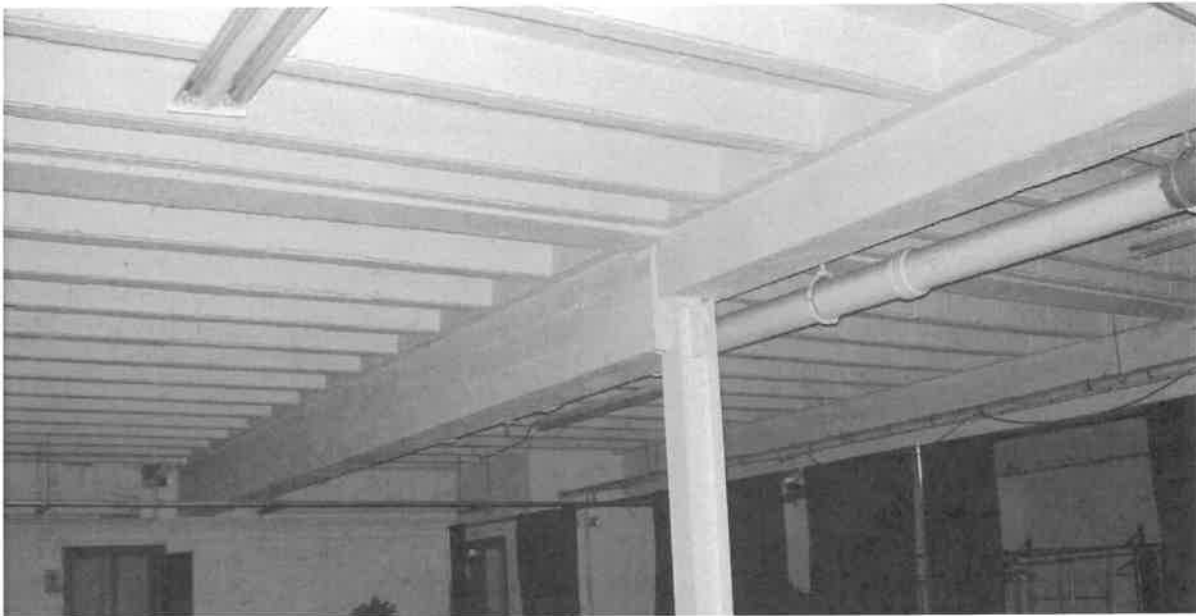
In the basement, there is water ponding on the floor in places since the power has been shut off and the sump pumps cannot run. The structure of the main floor level appears to be a one-way concrete joist floor system. There are steel columns exposed in several locations. Whether the beams are steel encased on concrete or concrete beams is not known currently. The structure that could be viewed at this level appears to be functioning as intended with no major structural issues being identified. The dressing rooms and toilet rooms appear to be supported by structural concrete floor slabs and either steel beams encased in concrete or concrete beams.

Photo 7: Floor Framing is One-Way Concrete Joist and Beam System

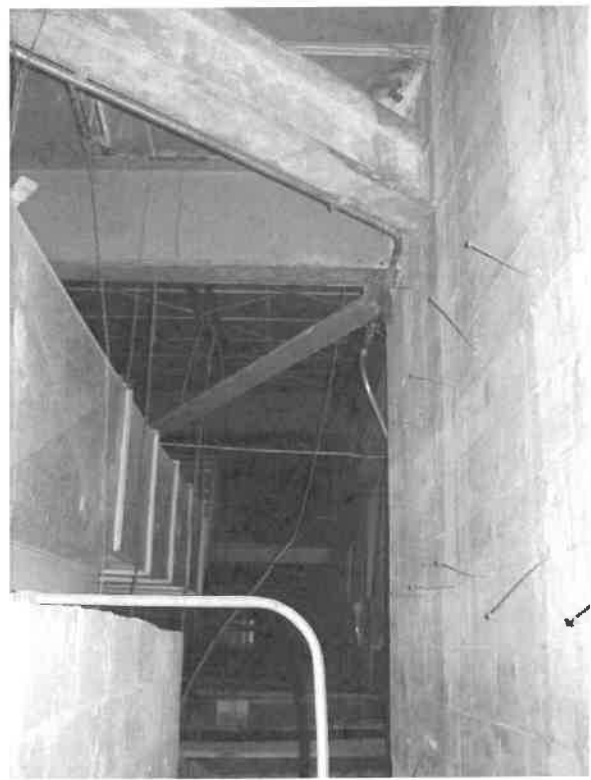
Photo 9: Steel Framing Supporting Ductwork

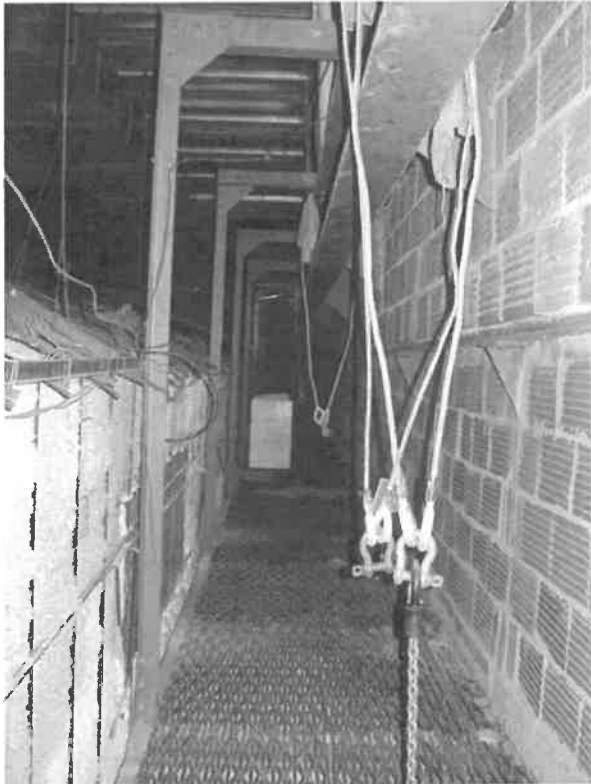
Photo 10: Catwalk Supported by Steel Structure and Clay Tile

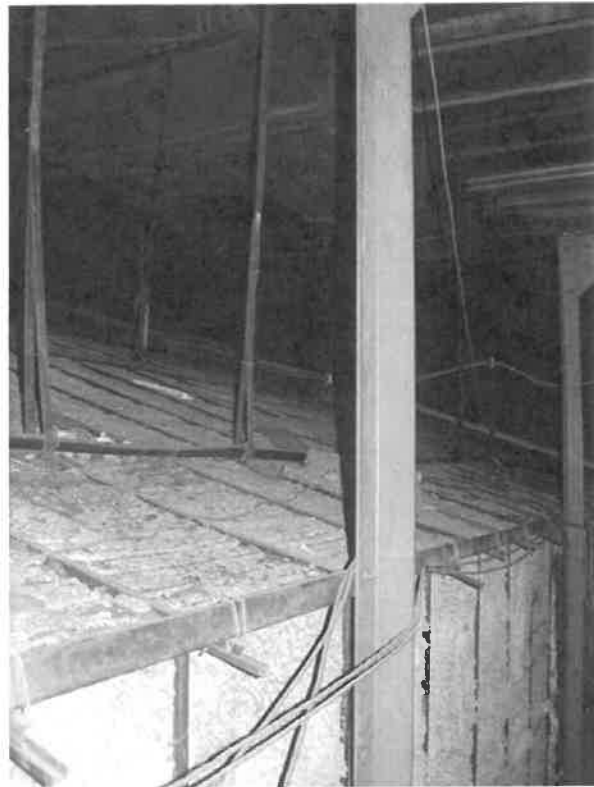
construction of the time. The plaster ceiling and ductwork and other utilities are suspended from the roof framing. Without actual measurements of the steel beam and steel joists, the capacity of the roof framing cannot be determined. Again, no major structural issues were found in the limited areas that could be viewed.

Photo 11: Plaster Auditorium Ceiling Supported by Steel Structure

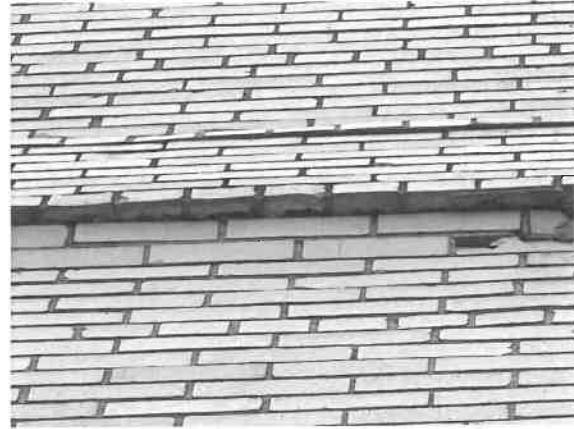
- Displacement of brick: In several places, the brick was observed to be displaced and buckling away from the building:
 - Faux Windows: At the west elevation of the building, significant displacement of the brick was observed between the faux window panels (Photograph 13 and Photograph 14). Per the original drawings, these were steel windows that have since been replaced with a brick infill. Between the top and middle rows of windows, the brick panel was severely buckled, and the brick was protruding from the face of the wall. There is a significant risk for this brick panel to fall based on the observed displacement. Corrosion was also observed at the steel lintels above each faux window (Photograph 15).

Photo 14: Displaced Brick at Faux Windows

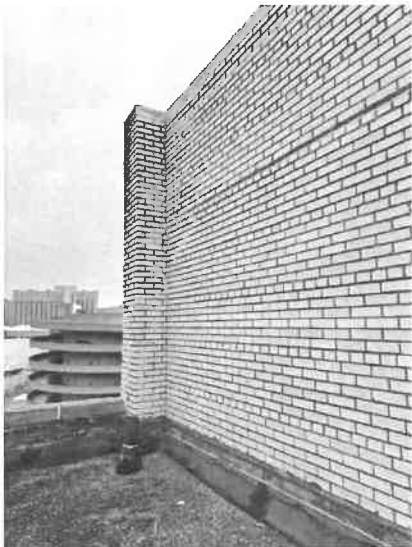
- Parapets: Displacement of brick was also observed near some of the parapets (Photograph 17). Similar to the displacement observed at the south elevation, this could be a result of corrosion of steel elements within the wall.

Photo 17: Displaced Brick at Parapets

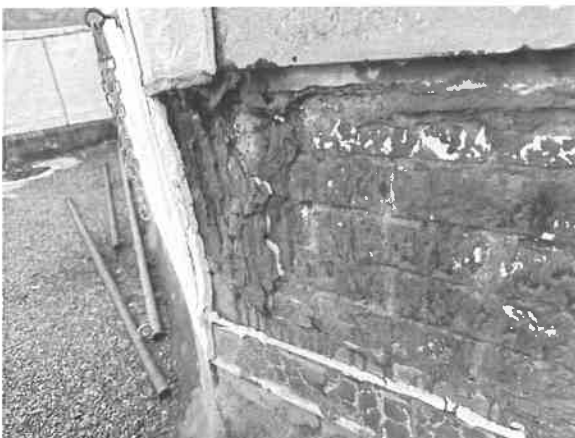
- **Drainage provisions:** With the size of the flat roof assembly, there were limited drainage provisions for the roof. Roof drains were only observed in a few locations, and the staining patterns and biological growth (Photograph 27) throughout the roof indicate that the roof is not draining sufficiently.
- **Termination:** Where the roof terminates against adjacent brick masonry and parapets, potential paths for water to penetrate behind the roof membrane were observed (Photograph 28 and Photograph 29).

Photo 29: Roof Termination Between Brick Masonry Wall and Concrete Façade

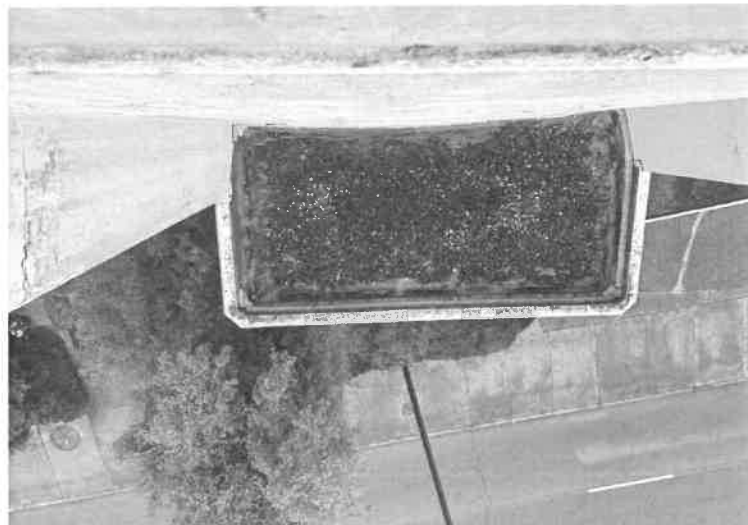
- Water infiltration at ticket office: Significant plaster damage was observed over the ticket office at the south elevation of the building from apparent water infiltration (Photograph 36). It is likely that the source of water infiltration is at the integration of the awning and the concrete wall (Photograph 37). Further evaluation would be required to determine the source of water infiltration.

Photo 37: View Looking Down at Top of Entrance Awning

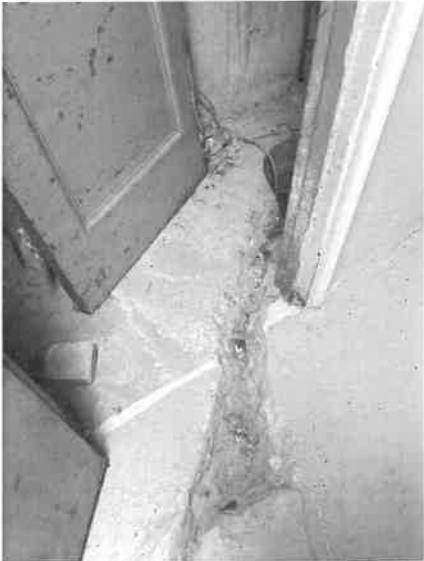
Water infiltration was noted in the basement during the interior tour, although it was not actively leaking at the time of the WDP site visit. Where significant water infiltration is known to occur, a series of trenches have been cut within the concrete floor (Photograph 39) to drain water to a pit where a sump pump is used to manage the water (Photograph 40). The source of the water infiltration is unknown, and it was noted to occur at interior walls. Further evaluation would be required to determine if the water infiltration is a result of the elevation of the water table, below-grade water infiltration at the perimeter that is making its way to interior portions of the building, or another source.

Photo 40: Trench Leading to Sump Pump

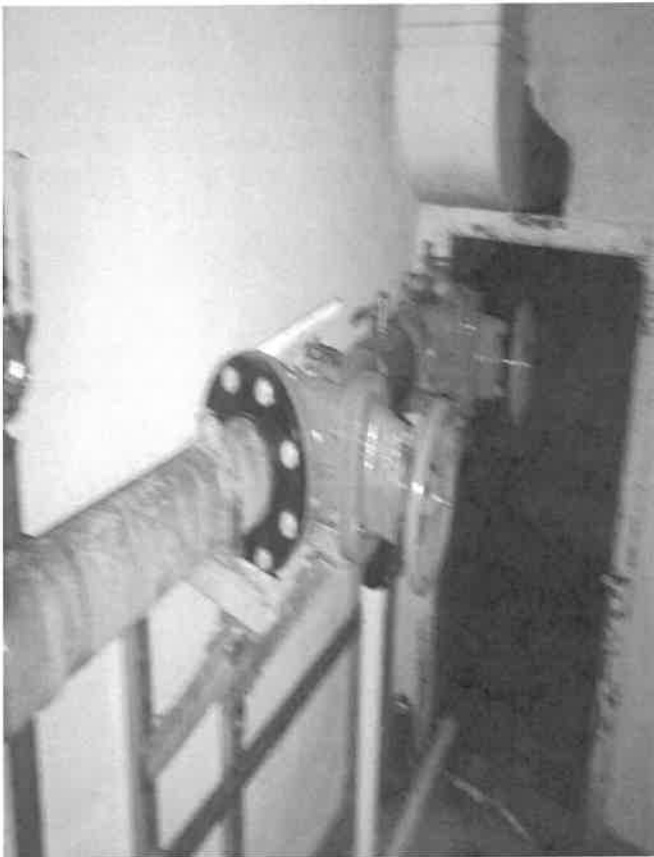
The facility is served by a galvanized 4" domestic water line that enters the corner of a utility closet in the basement. The potable water has a Watts model 957 backflow preventer installed on the main line in the utility closet. The backflow preventer was last tested in 2019 according to the inspection tag. The domestic service directly downstream of the backflow preventer is a copper line, but throughout the facility, the water piping material is a mixture of copper and galvanized. All galvanized domestic water should be replaced with Type L copper throughout the facility.

Photo 46: Main Water Service and Backflow Preventer

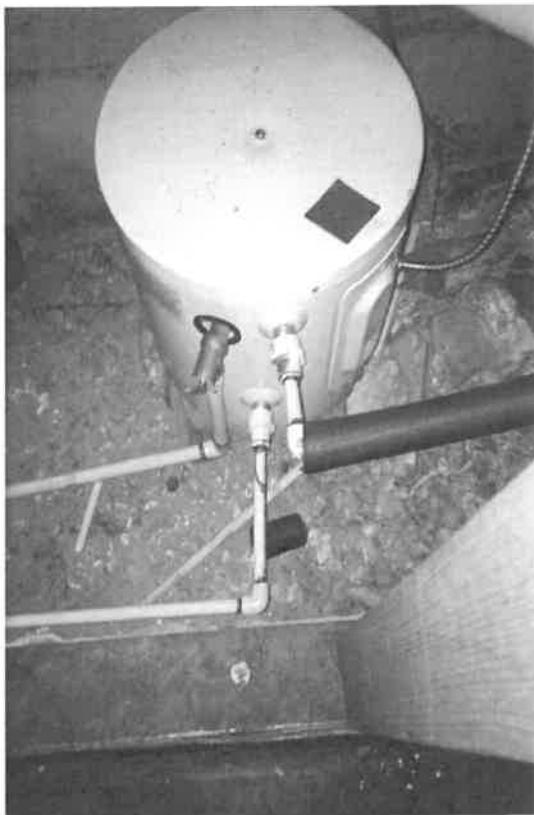
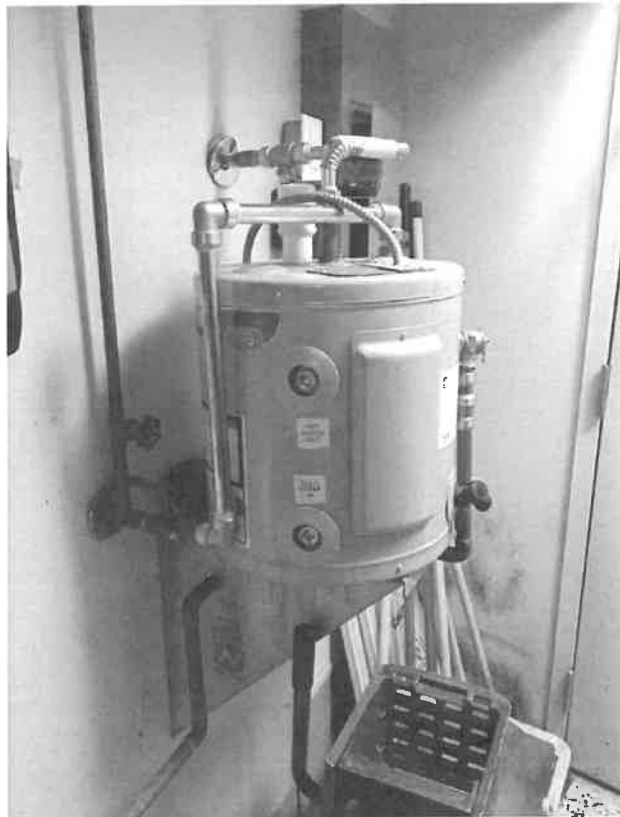
- There are no expansion tanks installed on the domestic hot water tanks throughout the facility. The expansion tank's purpose is to absorb excess pressure built up from the water heater, so the domestic water system and equipment does not get damaged.

- The domestic hot water piping throughout the facility consists of piping runs more than 50 feet in length with no hot water recirculation to maintain consistent water temperatures. Per the 2018 IPC, 607.2 The developed length of hot or tempered water piping, from the source of hot water to the fixtures that require hot or tempered water shall not exceed 50 ft in length.

Photo 48: Electric Hot Water Tank

Photo 49: Electric Hot Water Tank

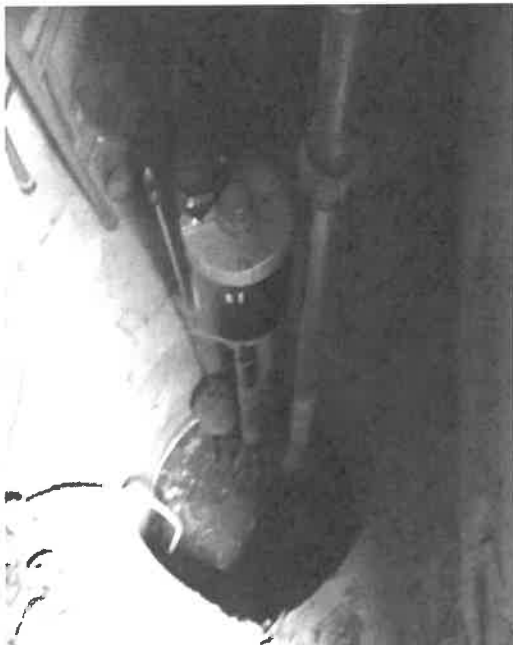
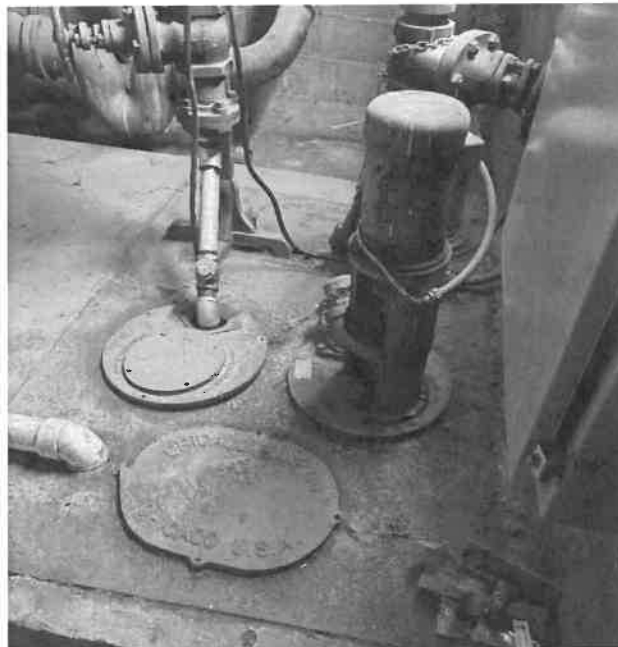
There is a ½ hp sump pump located in the basement that helps control ground water that enters the basement. Additionally, all sanitary sewer piping serving plumbing fixtures in the basement is routed to a duplex sewage ejector. Both the sump pump and the ejector have reached the end of their useable life and require immediate replacement. The new pumps should be connected to the building automation system (BAS) to monitor status.

Photo 50: Sump Pump

Photo 51: Duplex Sewage Ejector

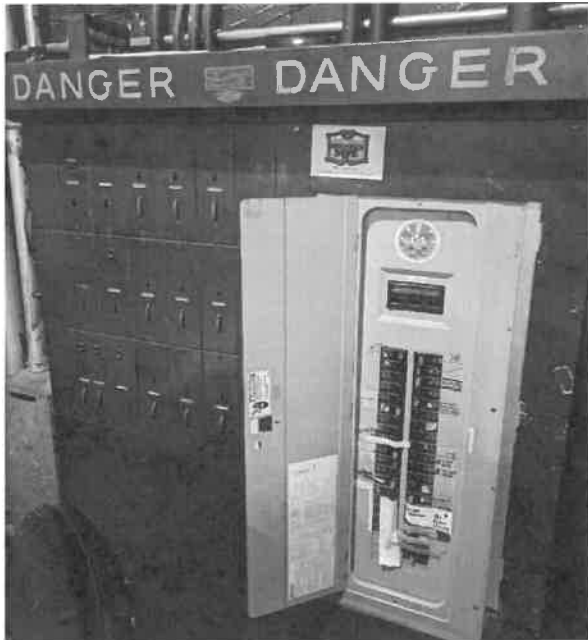
Photo 57: Abandoned Stage Dimmer - Retrofitted With Panelboard Compartment

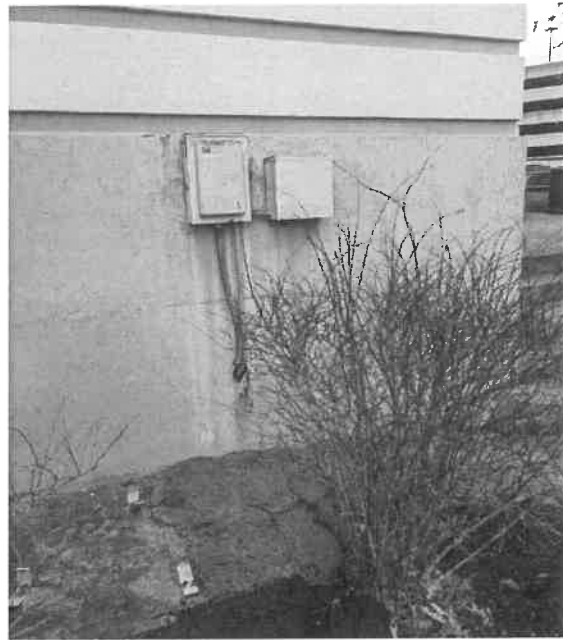
Photo 58: Abandoned, Unlocked with Exposed Wiring*

*Although power to box was not verified, existing disconnect and cabling should be removed entirely to ensure wiring does not inadvertently become hot – leading to fire or public life safety concern.

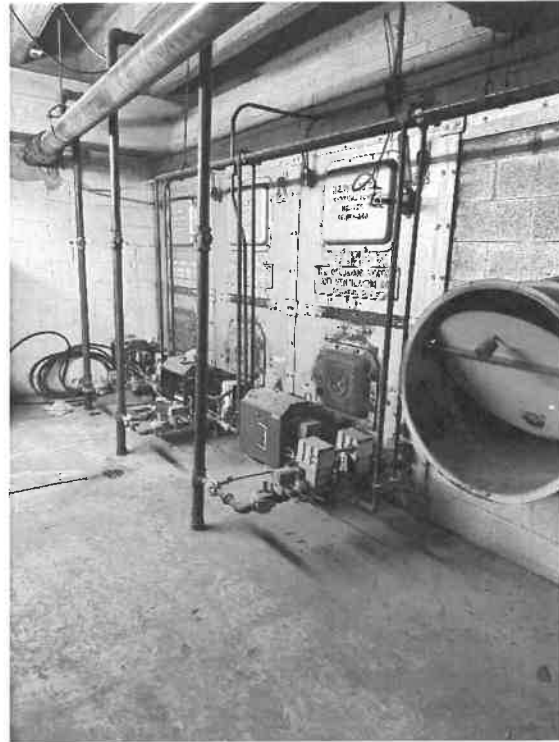
Photo 60: Existing Columbus Air Systems Unit
